SUSTAINABILITY OF A SAND – BENTONITE POLYMER GEL. AN EVALUATION OF LAYERS OF TRISOPLAST EXCAVATED FROM OLD TOP BARRIERS

Dr. ing. Huib MULLENEERS, Ing. Eugène TIMMERMANS
TRISOPLAST Mineral Liners

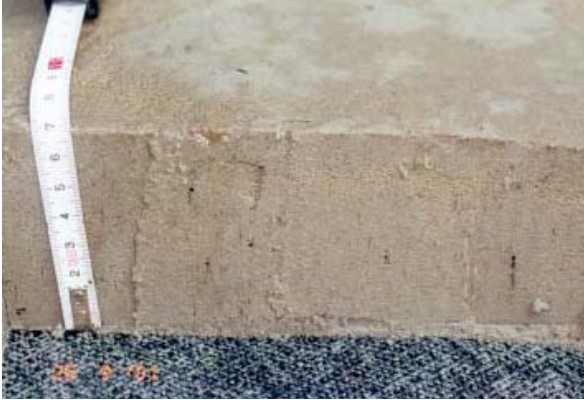
Photograph 1. Check of layer thickness after excavation

All eight of the layers tested had a visibly homogeneous colour, water content, density, thickness, plasticity and structure. There was no indication whatsoever of dehydration or cracks (*photograph 1*).

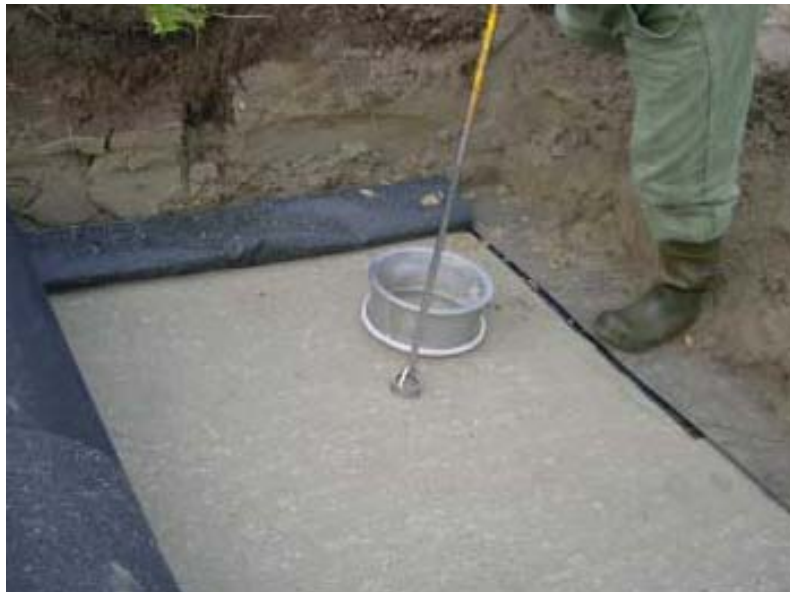
Photograph 3. Taking a sample during excavation

Sample rings specially developed for the excavation (*see photographs 3 and 4*) were used, amongst other things, in order to determine the permeability. The permeability after excavation was compared with that measured during construction. From this it proved that the currently measured values do not differ from those achieved during the construction
